Green Infrastructure Bio-Swale, Stormwater Capture and Reuse Project City of Springfield, Illinois

Presented by: Lee Bloome, P.E. – Hanson Professional Services Inc.

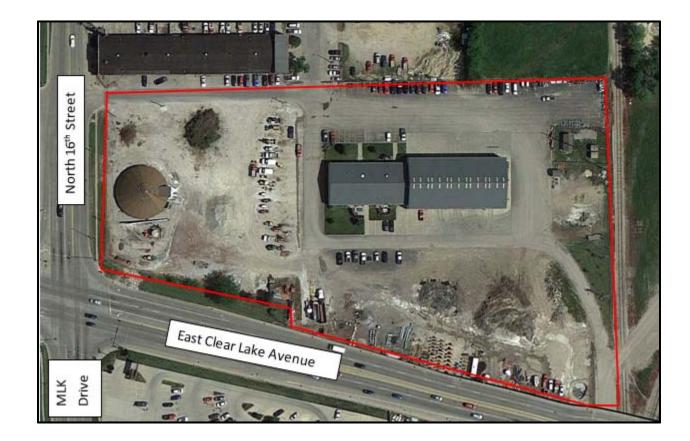
• The City of Springfield's Sewer Garage facility is an active site that contains the City's salt dome, equipment storage and temporary storage of construction debris and yard waste.

• Existing site issues included salt laden runoff leaving the site to the southwest and the potential for high suspended solids entering the combined sewers that serve the site.

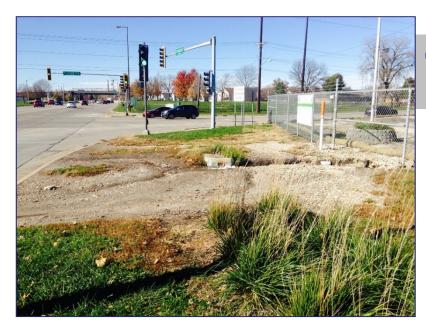
Brine Runoff and Eroded Soil

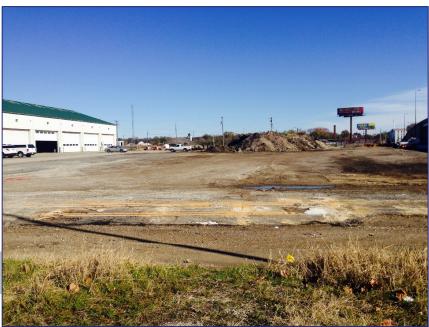
Construction material storage. No vegetated buffers.

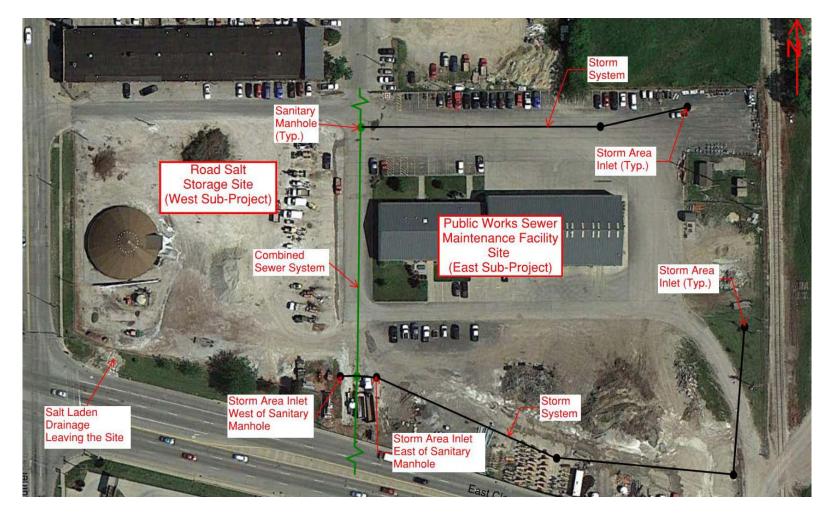
• Existing site drainage is collected by storm sewers on the east side of the site and one inlet on the west side of the site which are tributary to a combined sewer running from north to south.

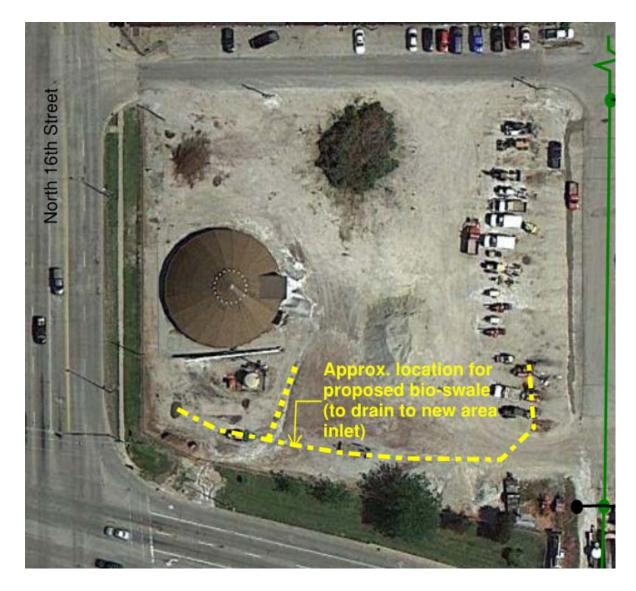
Project Need West Site:

- Intercept site runoff.
- Redirect drainage to the south.
- Maintain site usefulness.
- Do not impact future material storage building.

- The Iowa Stormwater Management Manual was used when designing the bioswale.
 - 4:1 max side slopes will allow for maintenance and mowing.
 - The underdrain pipe and drainage medium will be encapsulated in geotextile to prevent clogging.
 - The engineered soil ratios were field tested by the contractor and confirmed by the engineer before the final matrix was mixed and installed.
 - The resulting basin tapers from west to east and has a volume of 5,575 cubic feet and can capture up to 0.91" of a rain event.
 - Greater rain events are bypassed to the combined sewer inlet east of the basin.

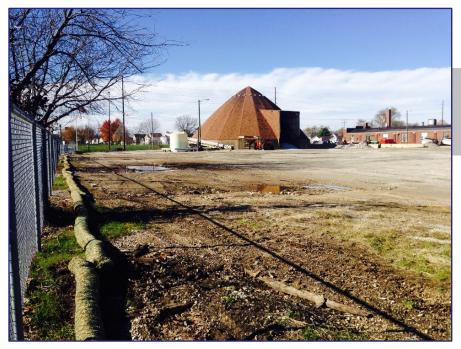
West Site Preconstruction:

West site looking west prior to construction.

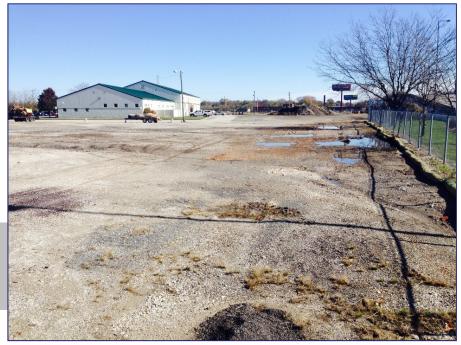
West site looking east prior to construction.

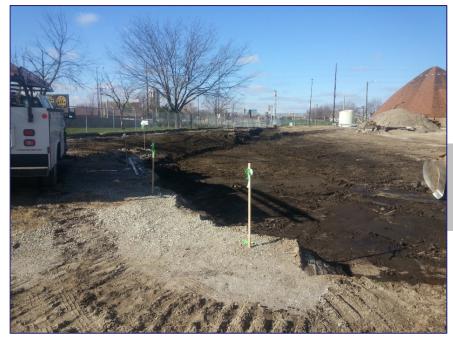
West Construction:

No surprises were found while excavating. Since the area used to be residential there was the potential for house foundations.

Looking west at the start of grading.

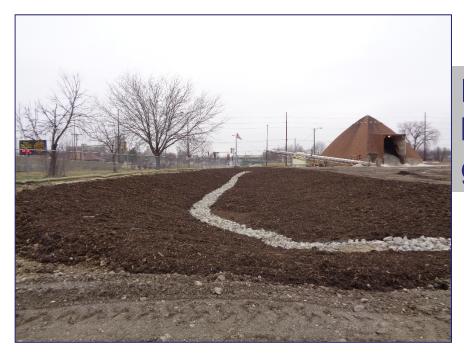
West Construction:

Looking west at the finished bioswale prior to seed germination.

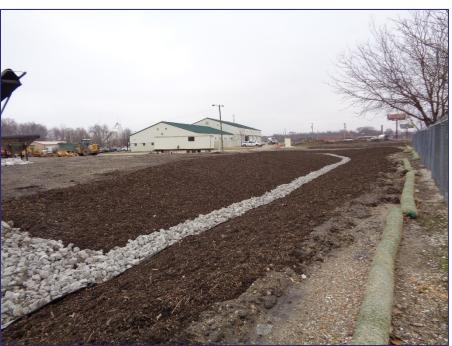
Looking east. The drop down pilot channel from the west side of the site is visible to the left.

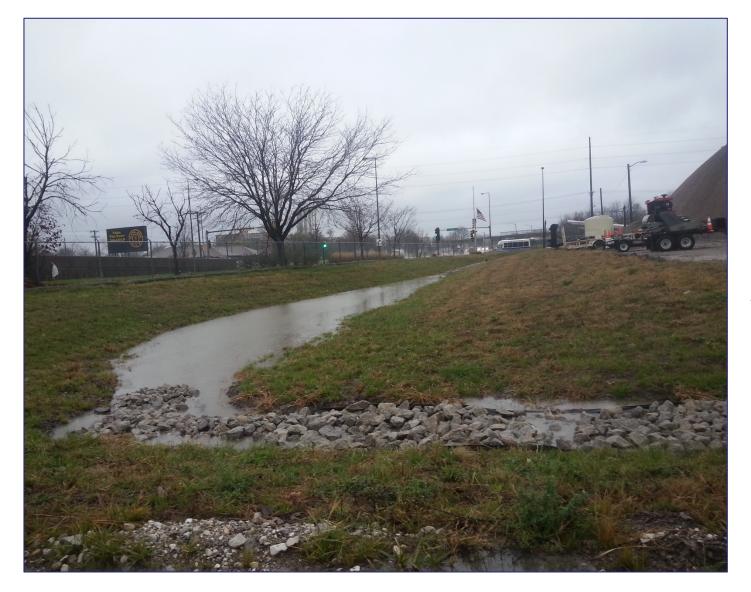
Finished Bioswale:

Photo taken after a 0.81 inch rain event

Nov. 17, 2015.

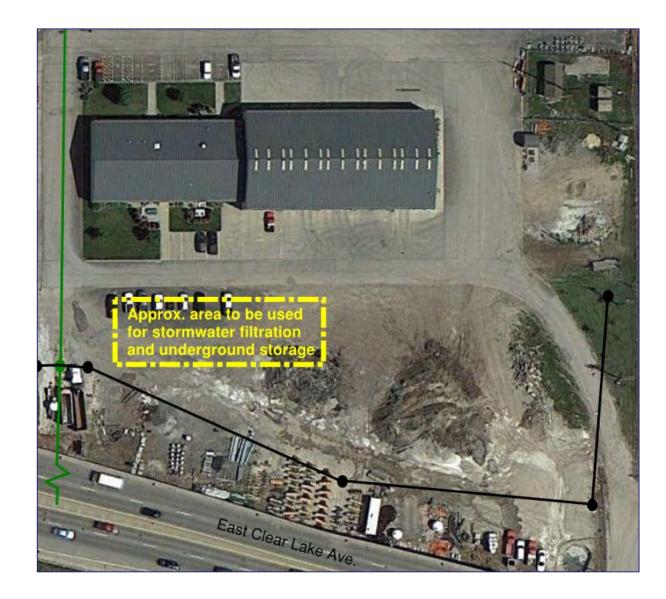
Project Need East Site:

- Intercept storm runoff.
- Provide storage.
- Maintain site usefulness.
- Keep the footprint as small as possible.
- Convenient truck filling location.

- As Hanson reviewed the site, the following base design criteria was used for the east project:
 - The east project would harvest rainwater for reuse.
 - Water use by the City's sewer jetting and planter watering totals 1.4 million gallons per year at the sewer garage facility or roughly 117,000 gallons per month.
 - The water reuse would need to filter to 10 microns to protect the pumps in the sewer jetting trucks.
 - Disinfection would be required per Department of Public Health requirements for plant watering.

- A rainwater harvesting runoff calculator from Contech was utilized to optimize rainwater storage vs site stormwater runoff.
- The following parameters were entered into the calculator:
 - Drainage areas with runoff coefficients.
 - Project location.
 - Daily water demand.
- The calculator simulates runoff using 20 years of historical rainfall data for your specific location.
- The calculator confirmed we had enough site runoff to provide the 117,000 gallons per month and the optimized storage volume was calculated at 124,000 gallons.

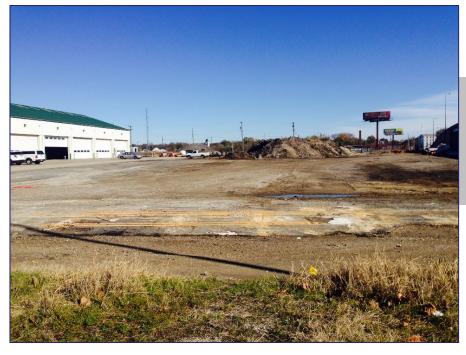
East Site Preconstruction:

East Site Looking East. Earth Stockpiled in the Background.

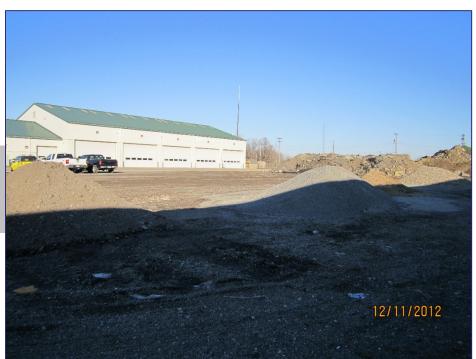
East Site Looking Northeast. Multiple stored materials.

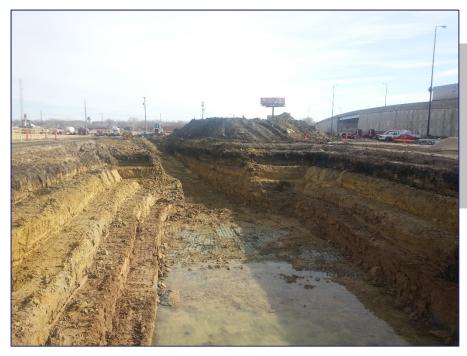
Underground detention excavation. Excavation dimensions 18'D, 66'W, 106'L

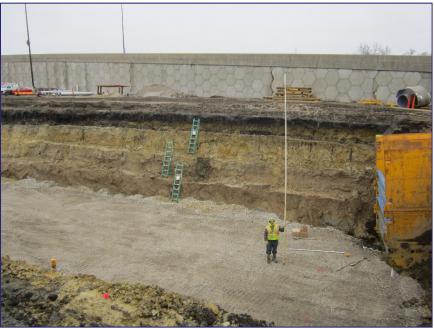
Installing the base course. The hydrodynamic separator is located to the right.

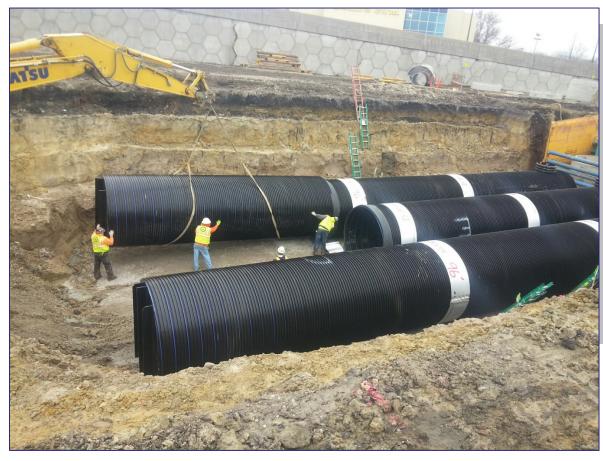
Installation of the 96" diameter Duramax pipe. Three parallel storage pipes 78 feet in length.

The three pipe runs were plumbed in a serpentine fashion to allow for added stormwater clarification

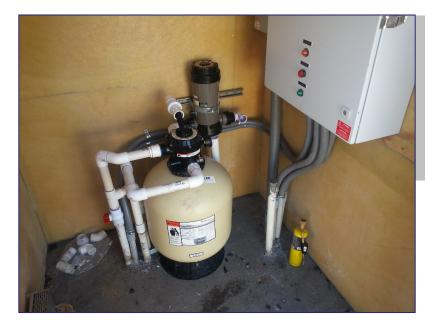
Sand filter and chlorinator being installed within the insulated and heated control building.

The control building and truck filling connection were incorporated into a concrete island.

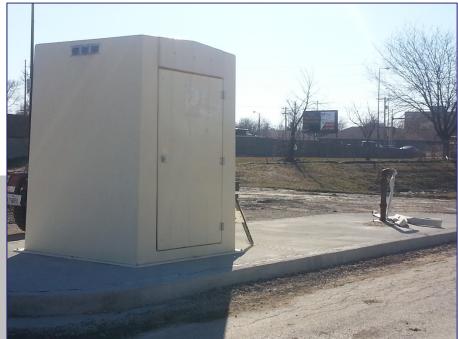
Controls to operate the pumps are simple toggle switches. Float switches provide pump protection.

Since the east site is used for raw material storage, the finished project looks like it did before construction with the exception of the island, fill pipe and access hatches.

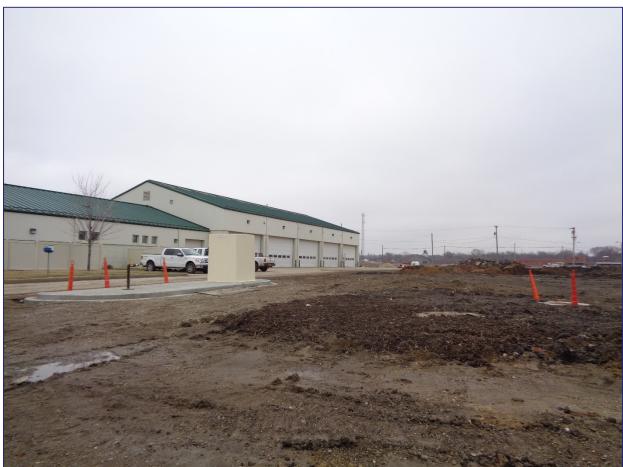
Sewer jetting trucks pull up parallel to the fill station, hook up their cam-lock hoses and flip the fill switch.

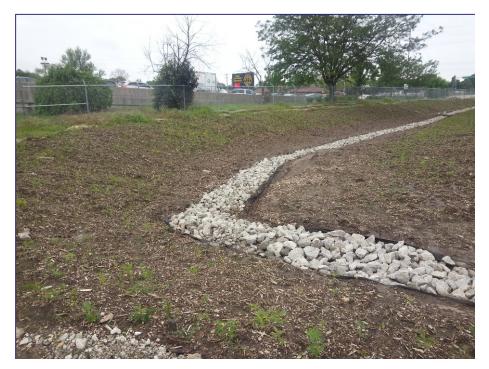
- The project had several design challenges that needed to be addressed during and after construction.
- The bioswale took an exceptionally long time to fill in with grass. The filter medium was placed loose and seeded so as not to overcompact it. There was plenty of moisture, but the seed did not spread quickly.
- Spring rains submerged the basin on multiple occasions with the water draining within a day of the initial filling. With the grass not established, there was some initial erosion along the edges of the pilot channel that needed to be filled this spring.

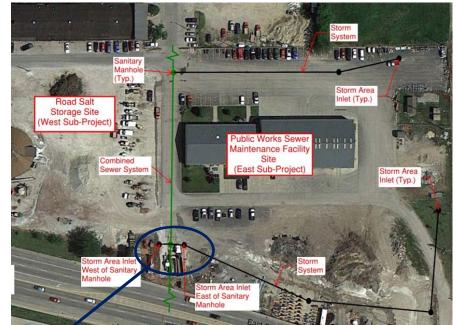
Location of the check valve

- During construction, it was observed that there was a potential for the combined sewer to surcharge far enough during large rain events that it could backflow into the rainwater collection system.
- Solutions were researched and it was decided that a check valve upstream of the tie in to the combined sewer would prevent any backups.
- A checkmate check valve from Tideflex was selected for its simplicity and that it didn't need a new structure for installation.

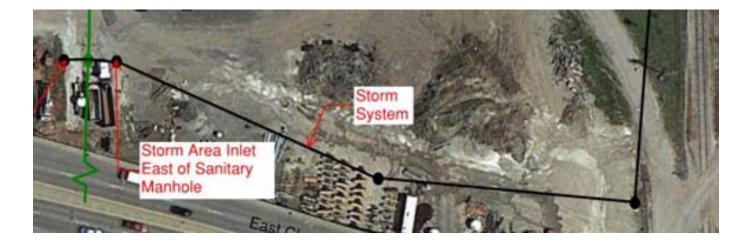
- The storm sewer wasn't done with surprises though.
- As the Contractor was tapping into the line to install the bypass manhole, it was discovered that concrete trucks has been washing out their trucks into the east end of the storm sewer and the resulting storm sewer, while still functioning, was over half full of concrete washout.
- The City utilized their vactor trucks and has cleaned a large portion of the washout from the line.

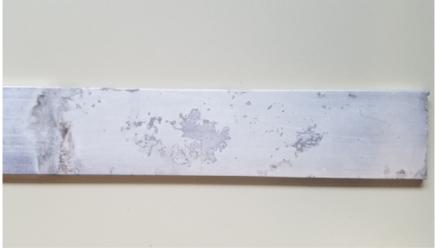
- We experienced another "lessons learned" when using the reuse water.
- The City's vactor trucks have aluminum water tanks for their jetting water. The tanks have a small filter plate to protect the pumps from debris and grit.
- Upon using the reuse water for the first time, the City personnel complained that there was a white "oatmeal" type floc that was plugging the filters and starving the pumps.
- We examined the day tanks and sampled the water. It was clear and free of debris. Initially we thought there may have been a biofilm that had sloughed off when the tank was chlorinated. This was determined to be incorrect.

- Remembering the concrete washout, we obtained a sample bottle of the filtered water and added a piece of aluminum to it. It reacted immediately causing oxidation and pitting in the bar.
- Subsequent water tests showed the water had a pH of 11.4.
- The pH of the water is raised as it flows through the old concrete washout the City hasn't been able to get out of the storm sewer. The pH has slowly been lowering with subsequent flushing to a point where it will not be reactive to the aluminum tanks.
